## YANGTZE DYKE AND ITS STRENGTHENING

**ABSTRACT:** Levees play important role in flood prevention. More than 30,000 km length of levees protect the rich and populous plain regions of the middle and lower reaches of Yangtze River. However, the quality of the levee varies greatly in different regions. This paper summarizes the characteristic of Yangtze dyke, its main dangerous situations and hidden defects, together with the measures for handling these problems.

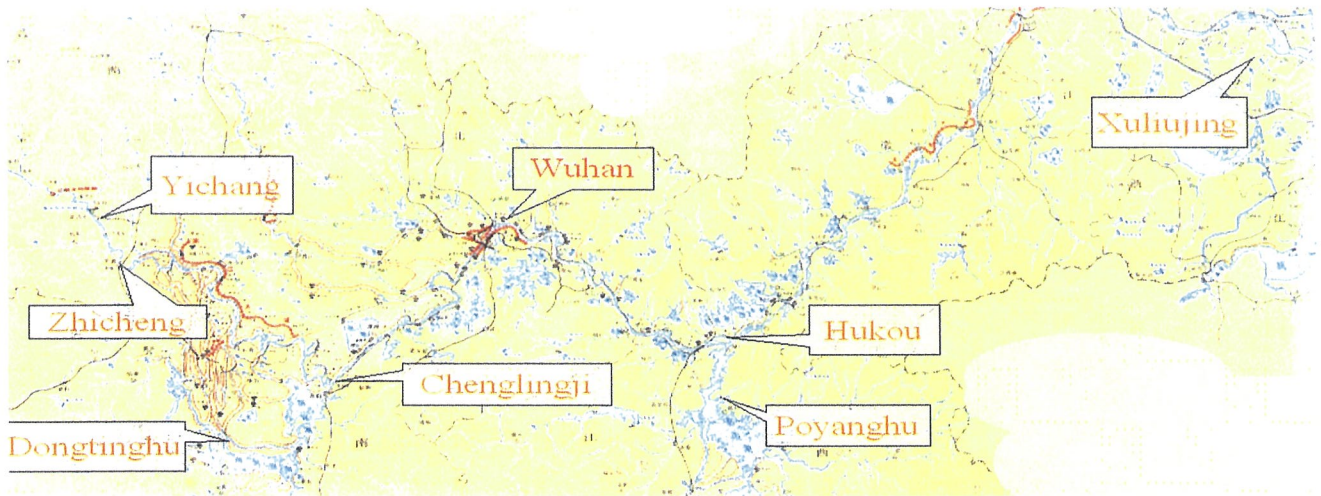
Fig. 1 Sketch of Yangtze valley

From Yichang (in Hubei province) to Hukou (in Jiangxi Province) is the middle course of Yangtze River, where the course from Zhicheng to Chenglingji is also called Jingjiang River (See Fig. 1). The river winds at Jingjiang with low flood discharging capacity, and consequently the flood situation is very severe. The 50 km long stretch downstream of Hukou is the lower reach of Yangtze River (see Fig. 1).

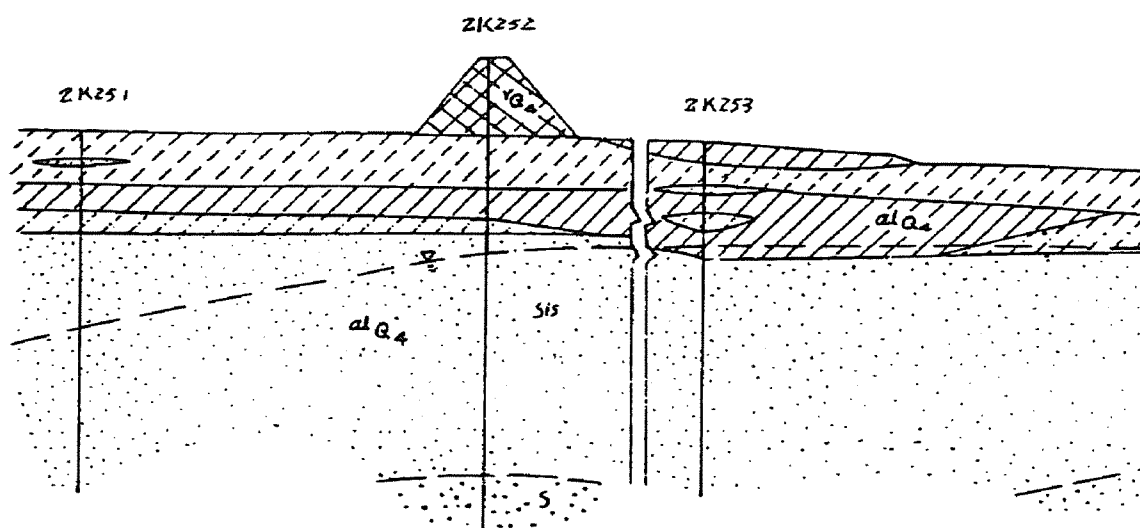
Fig. 2 Levee with two-layer foundation

Yangtze levees are mainly situated in the plain region called Jiangnan Plain, in the middle reach of Yangtze River. Most of the foundations (more than 70 percent) are two-layer foundations consisting of the weakly pervious surface layer and the pervious underlying layer (see Fig. 2). Generally, the soil in the surface layer is clay, silty clay or silt, while the soil in the underlying layer is mainly pervious soil such as sandy gravel, sandy cobble and decomposed bedrock, etc. This two-layer structure is generally suitable for seepage control. But if the stream trenching destroys the surface layer at the river side of the dyke, or the excavation and reclamation destroy the surface layer at the land side, seepage failures such as soil flow and piping may be induced at high water level, which are the main causes of dangerous situations in flood period.

For the two-layer foundation of the dyke, the weakly pervious surface layer at land side of the dyke will be burdened with a high water pressure when the flood water reaches a high level. Seepage failure will occur if the exit hydraulic gradient is high. It has been shown by the investigation that the seepage failure involves direct scouring, piping, soil flow, and local soil flow, etc.. The most dangerous of all is the seepage failure occurring at the toe of levee back. With the soil particles being gradually carried away by the flow and the seepage failure developing toward the dyke, differential settlement, cracking, collapse, or even dyke breaching will be induced. It has been recorded that more than 60 percent of the dyke failures were caused by seepages.

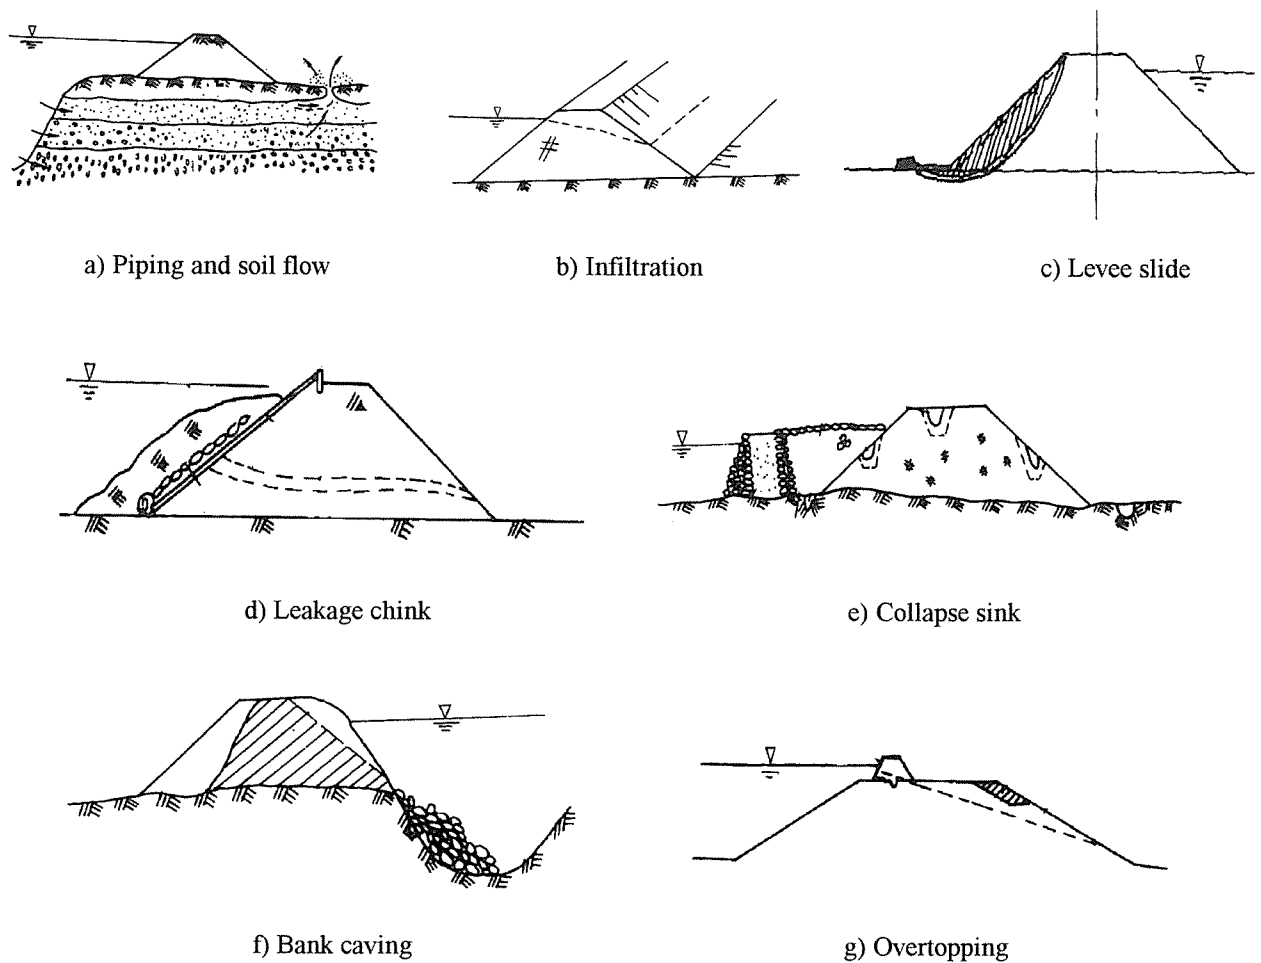
Fig. 3 Main dangerous situations

Figure 3 shows the main dangerous situation in the safety of the dykes.

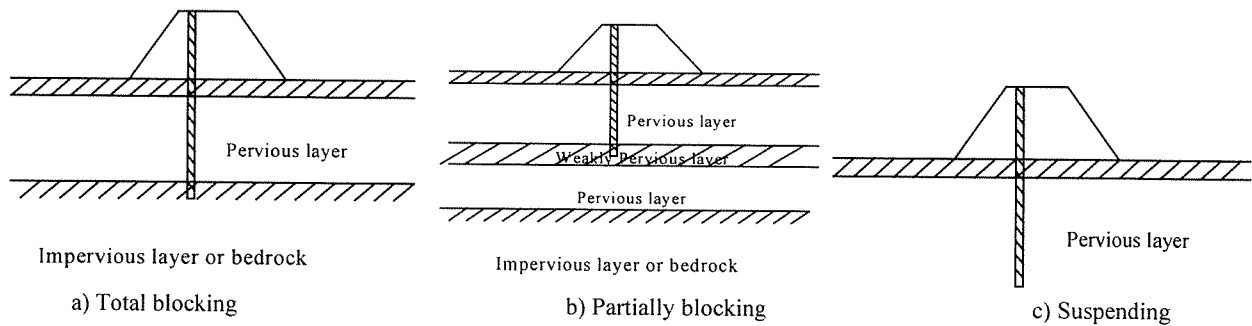
Fig. 4 Seepage control in vertical direction

direction essentially had the following three methods (see Fig. 4).

By this method, the seepage of the underground water is completely held up by the counter-seepage underground cut-off wall penetrating into the impervious layer or the bedrock. Theoretically, this kind of treatment can completely prevent the seepage and seepage failures. However, in order to reach the impervious layer or the bedrock, the wall will often be quite deep and expensive. Additionally, inland inundation and salinization will be induced if the underground water cannot be exuded to the river in low water period. So one ought to be very careful in applying this method.

According to this method, the vertical cut-off wall is penetrated into a relatively weakly pervious layer. Although the seepage is partially blocked, it was indicated by experiments and numerical analysis that the hydraulic gradient is greatly reduced at the outcrop. As a result, the resistance against the seepage failure is greatly increased.

If the pervious upper layer is too thick for the wall to reach the weakly pervious or the impervious lower layers, the wall is just built for a certain depth in the pervious upper layer. In a sense, it is being "suspended" in the pervious upper layer. The seepage path is extended by this method, whereas the hydraulic gradient at the exit is not decreased remarkably, only about 10 percent. However, it is shown by experiments that although it has little effect on the hydraulic gradient, this method can restrain the development of the seepage failure. On the other hand, this method is also useful in treating such hidden defects as cracking and holes in the dyke.
